Purpose: CERCLA Site Inspection

Site: Buckeye Properties
1296 Armstrong Ave.
San Francisco, CA

Date of Inspection: February 3, 1993

Report Prepared By: James M. James

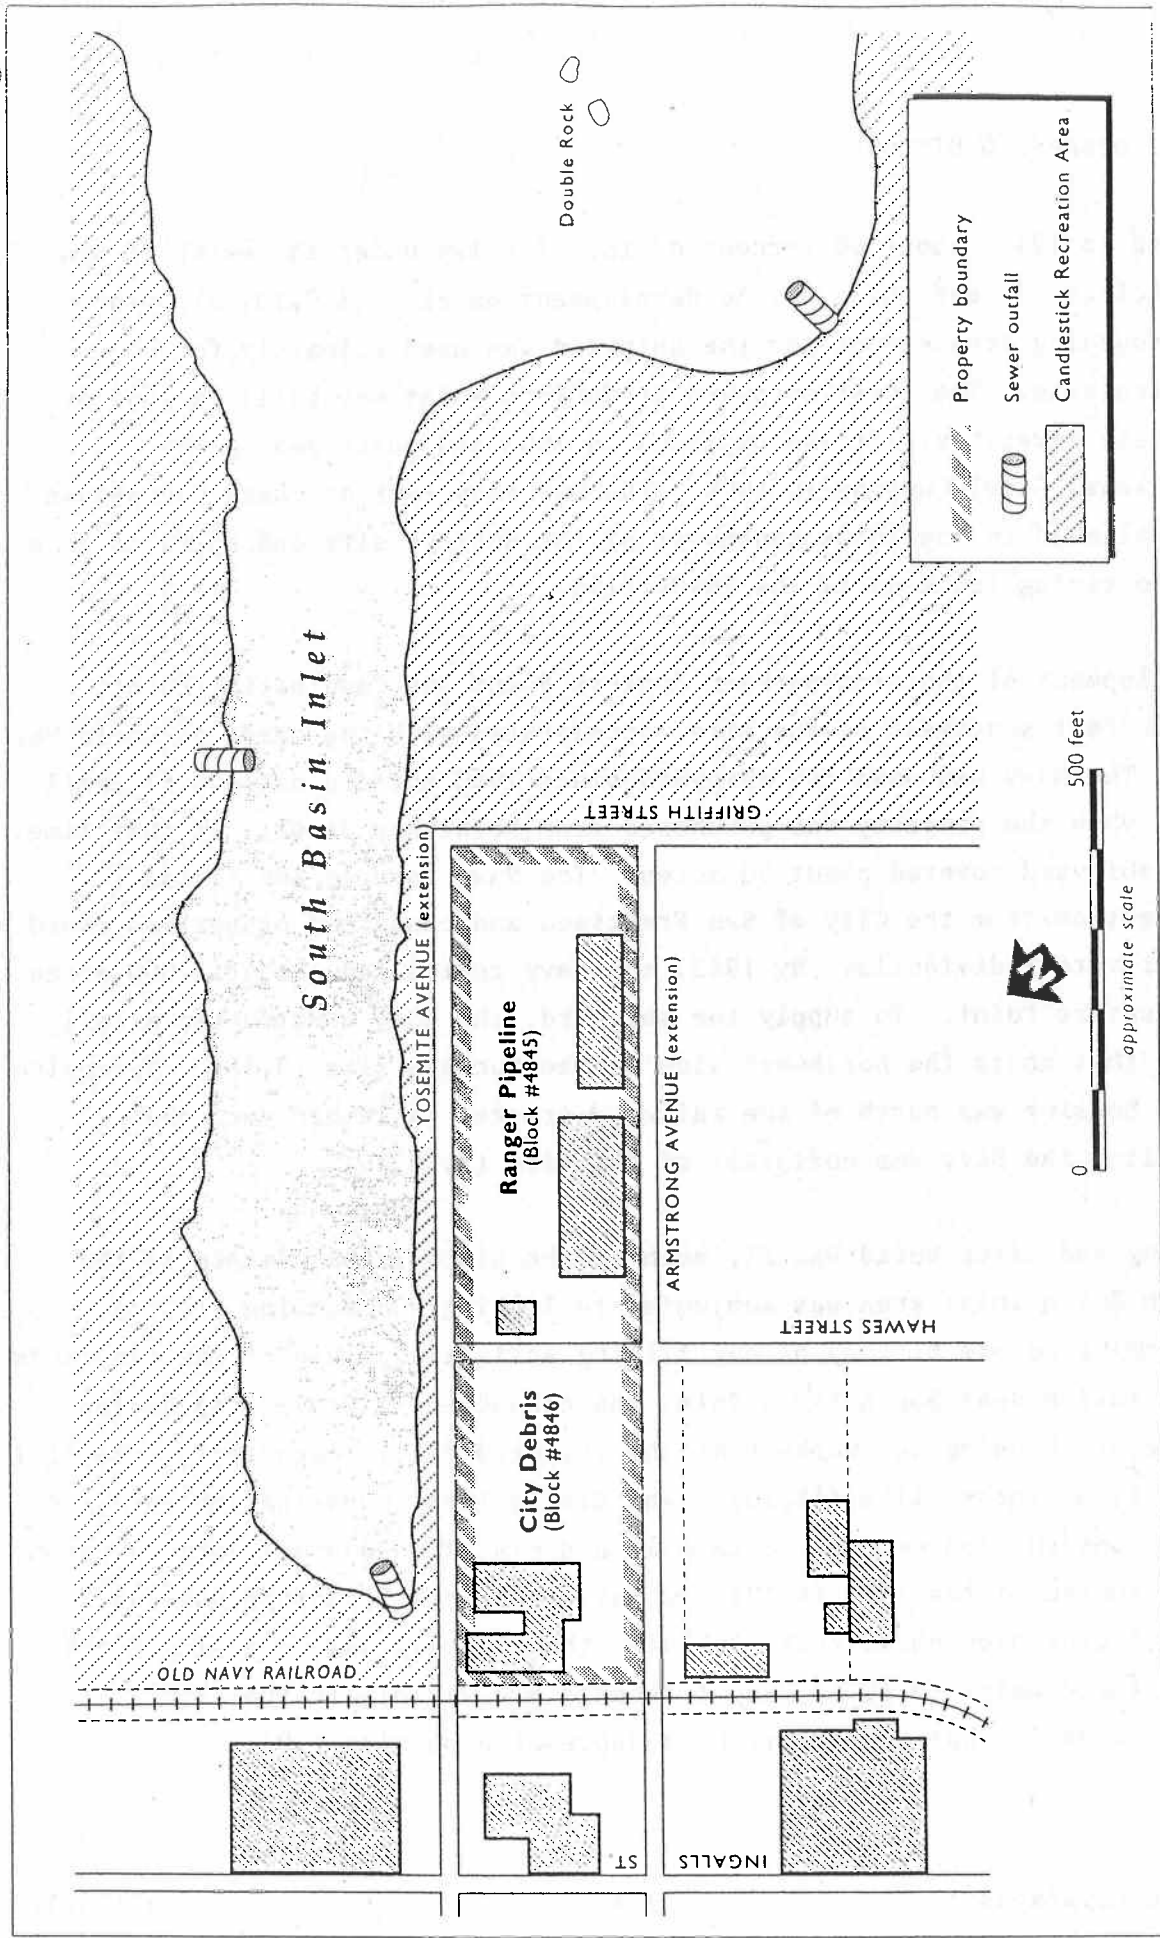
Figure 3-2
FACILITY MAP
Buckeye Properties
1296 Armstrong Avenue
San Francisco, California

To date, EPA has defined the site on the basis of the boundaries of properties owned by Buckeye Properties, Inc. The properties are on City Block 4845 and 4846, which are subdivided into many parcels (Figure 3-2) (9).

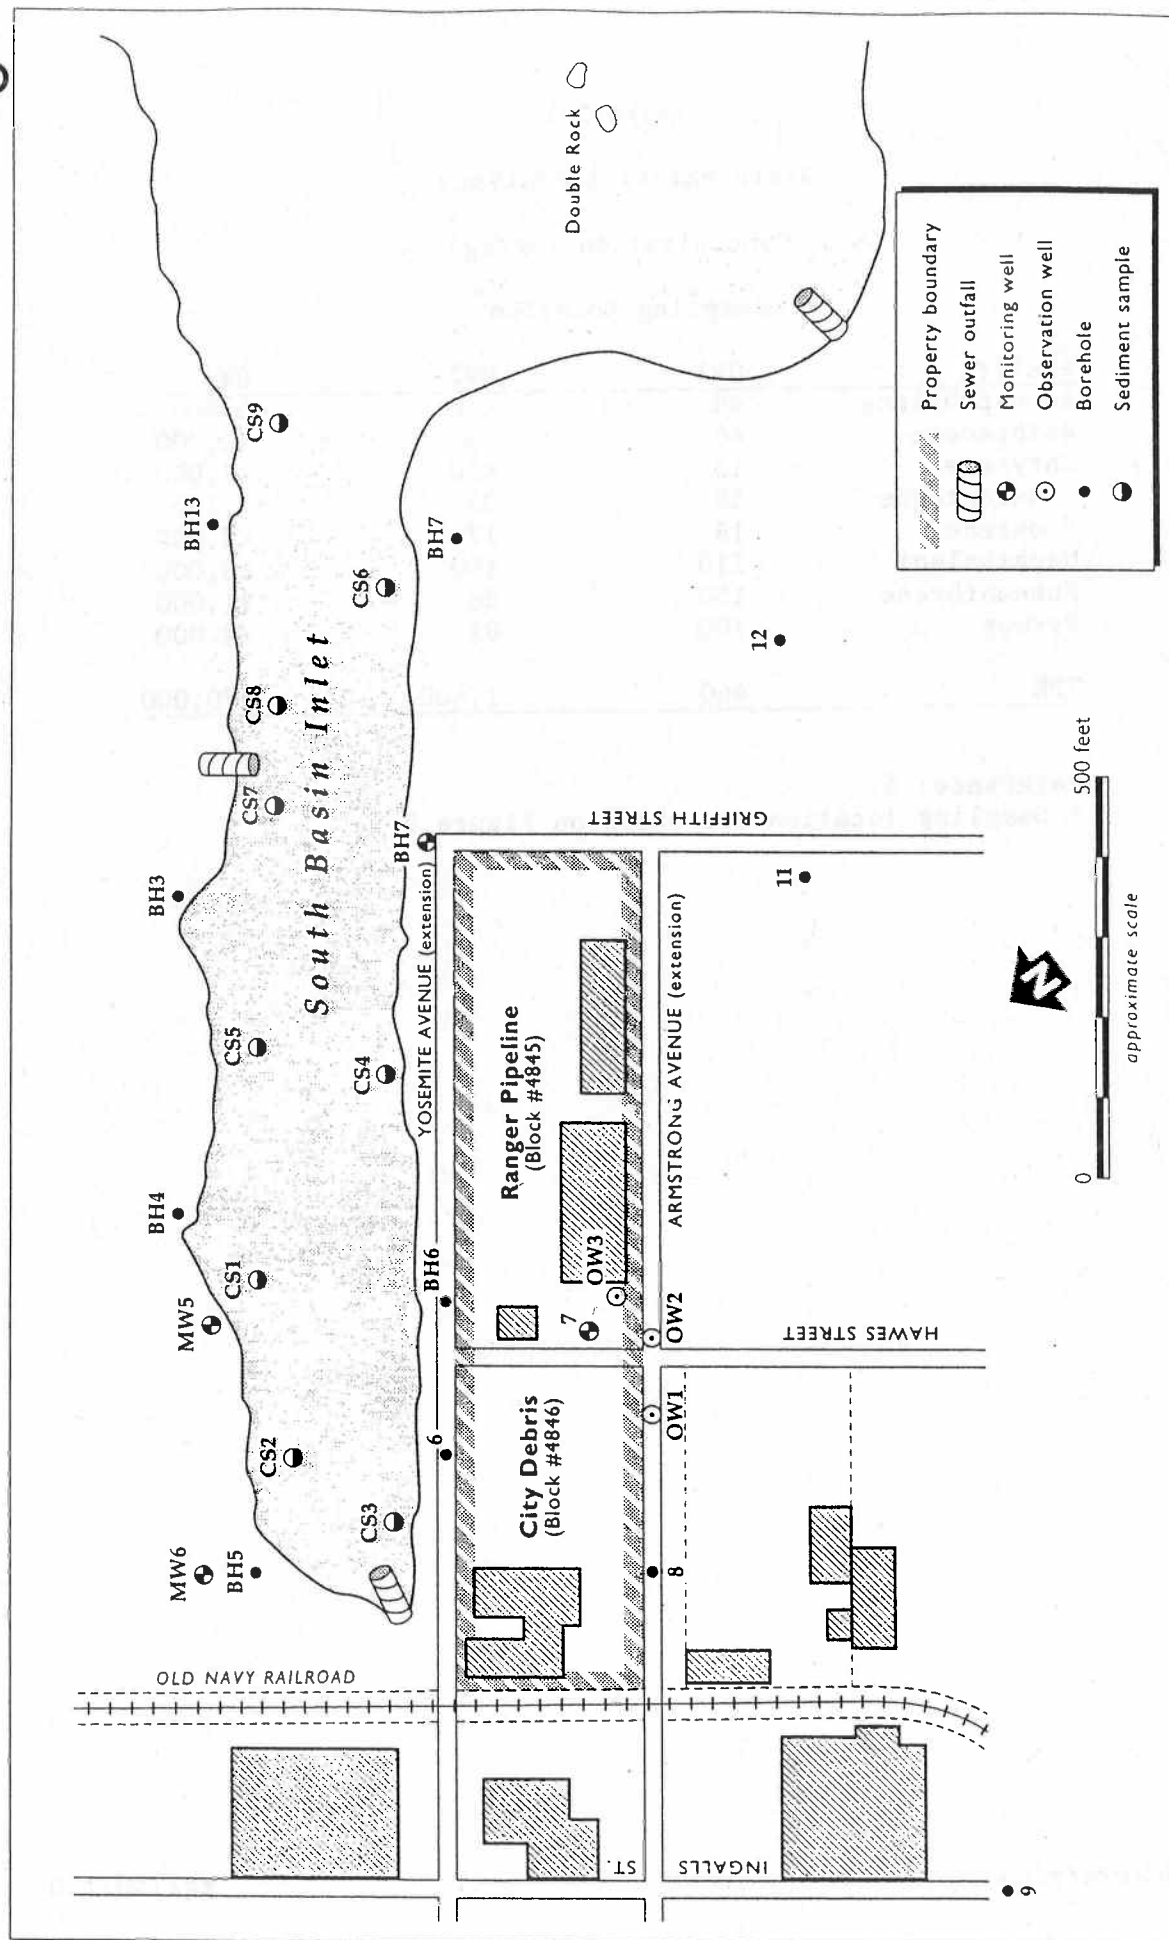
Figure 5-1
SAMPLE LOCATIONS MAP
 Buckeye Properties
 1296 Armstrong Avenue
 San Francisco, California

Investigations by the City from 1986 to 1989 revealed that contamination beneath the site contains metals and hydrocarbons. Table 5-1 summarizes the analyses of the waste. Photographs of the excavations indicate that visible contamination is not present within the first 2 feet below ground surface (bgs). Although the contamination is not contained by manmade structures, it is likely that vertical contaminant migration is impeded by bay mud that is encountered about 15 feet bgs. The lateral extent of the contamination is not known, but contamination of fill is widespread in San Francisco. Some of the wastes were removed during construction of the sewer pipe. Table 5-2 summarizes the analyses of on-site and near-site soils. Table 5-3 summarizes the off-site analyses. Figure 5-1 shows the sampling locations (4,5).
